Job No.	27266.03
By	M.L.
Date	28-6-22
Sheet	S-00221 T1

Project: 53 WARMINSTER RD, LONDON SE25 4DA
REMOVAL OF BURIED TANK

Job No.	27266.03
By	ML
Date	28-6-22
Sheet	S-00222 T1

Project: 53 WARMINSTER RD, LONDON SE25 4DQ

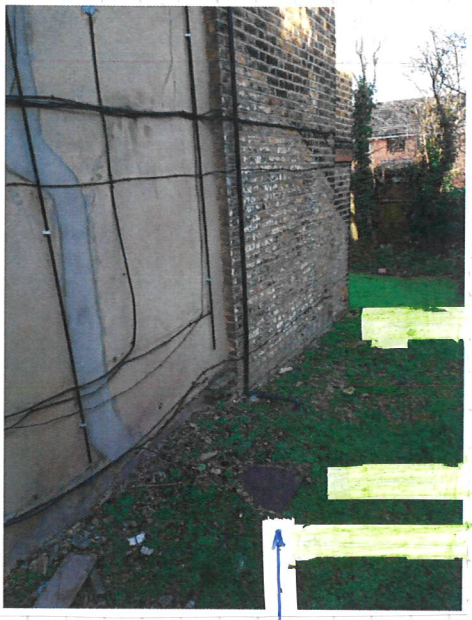
PART-BURIED STEEL/C.I. TANK

BURIED METAL TANK

GARDEN WALL STEP IN HEIGHT

1. SEQUENCE FOR REMOVAL OF BURIED TANK:
   a) EXCAVATE AROUND WITH HAND-HELD TOOLS
   b) NOTIFY ENGINEER IF TANK EXTENDS BENEATH WALL & SUBMIT METHOD FOR REMOVAL
   c) CHECK FOR ANY CONNECTIONS TO TANK
   d) ONCE METHOD AGREED, CAREFULLY REMOVE TANK & DISPOSE OF
   e) BACKFILL WITH COMPACTED ORIGINAL MATERIAL IN 250 THK LAYERS
   f) REINSTATE TOPSOIL

2. COORDINATE EXCAVATION OF TANK WITH ACCESS FOR RESTRAINT TO SOUTH GABLE WALL. REF. SHT. S-00220

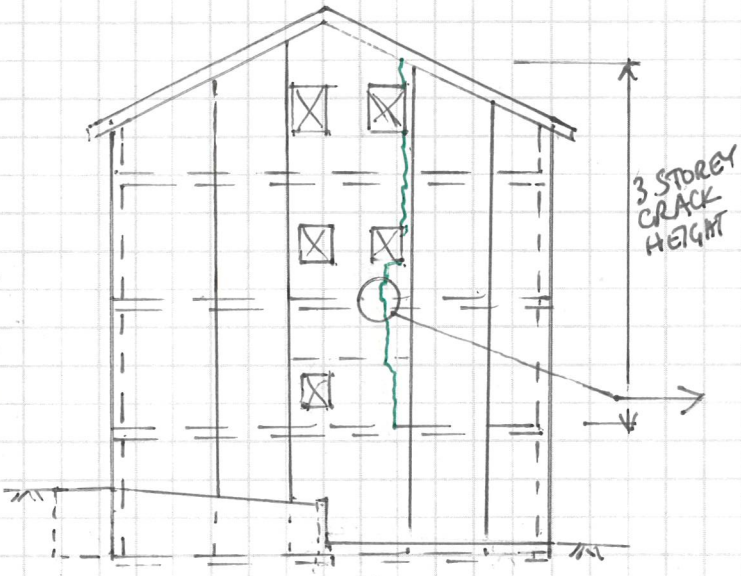
SECTION D-D
EXTERNAL FACE

BRICKWORK CRACK REPAIR
