Gary Page
Cluttons LLP

53 WARMINSTER ROAD - PROGRESS

Tuesday, 25 October 2022

Prepared For Brymore No 1 Ltd

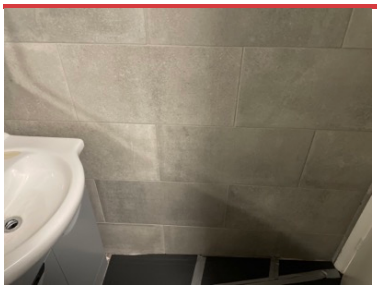
OBSERVATION 8

Flat D first floor hallway

Structural partition

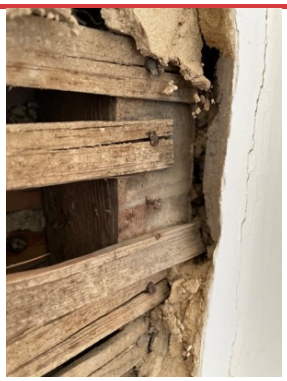
OBSERVATION 10

Flat D first floor

Partition strengthening here which is the opposite side to bathroom

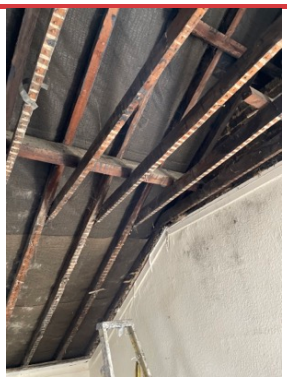
OBSERVATION 12

Flat D

Rear wall thickness circa 425mm, TBC

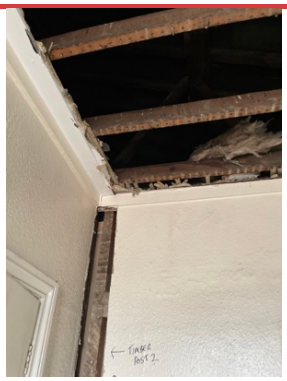
OBSERVATION 14

Flat B

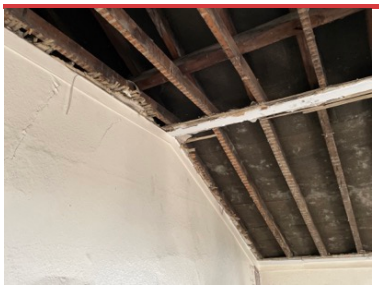
OBSERVATION 18

Flat B rear lounge

Roof timbers noting purlin location for temporary works

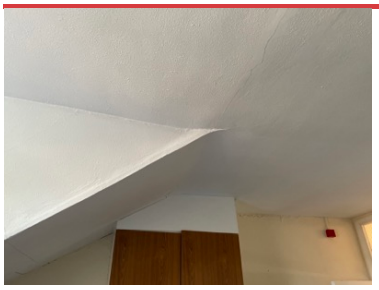
OBSERVATION 20

Flat B rear lounge

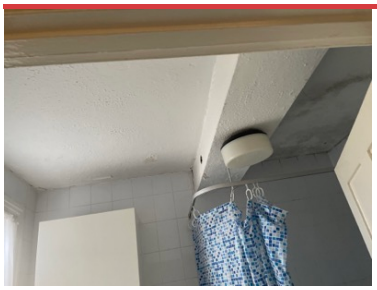
OBSERVATION 23

Flat A. Wall to staircase.

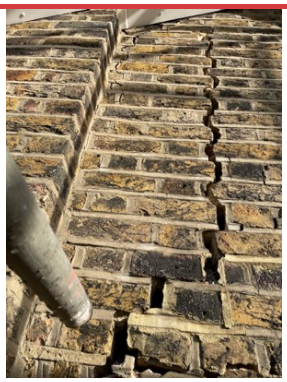
OBSERVATION 27

Large crack above dropped window

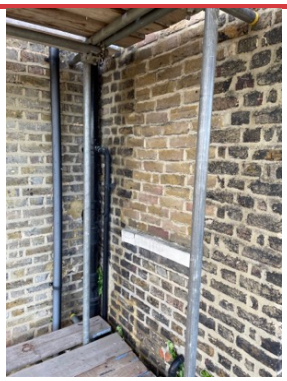
OBSERVATION 29

Asbestos flue to be removed here and in void.

Trace how far is goes down through the building for records
