53 WARMINSTER RD - PROGRESS

Tuesday, 1 November 2022

Prepared For Brymore No 1 Ltd

23 Observation Identified

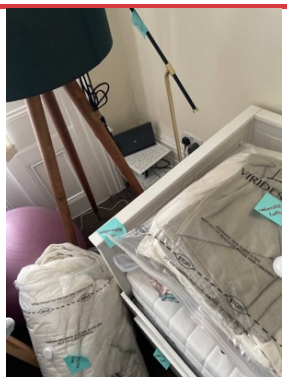
OBSERVATION 15

Flat E

Wall separating Flat F where loading from revised bay window may be required.

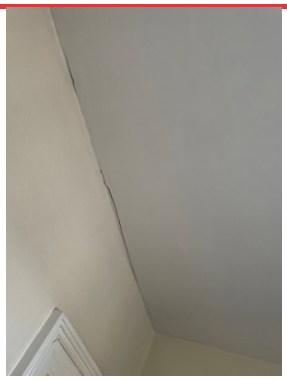
OBSERVATION 18

Flat E

Left flank side hallway

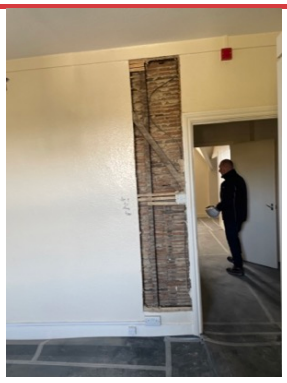
OBSERVATION 19

Flat E

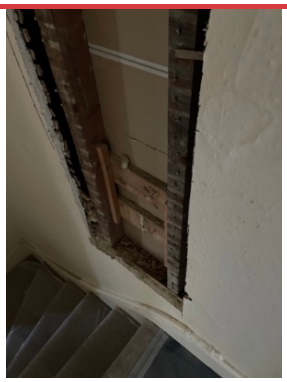
OBSERVATION 21

Flat C

Central hallway stud exposed separating the rear lounge.

Depth from back of lath to wall finish is 120mm.
